DOWNTOWN REDEVELOPMENT PLAN

CITY OF GROVE CITY, OHIO

MARCH, 1987

TROTT & BEAN ARCHITECTS, INC.

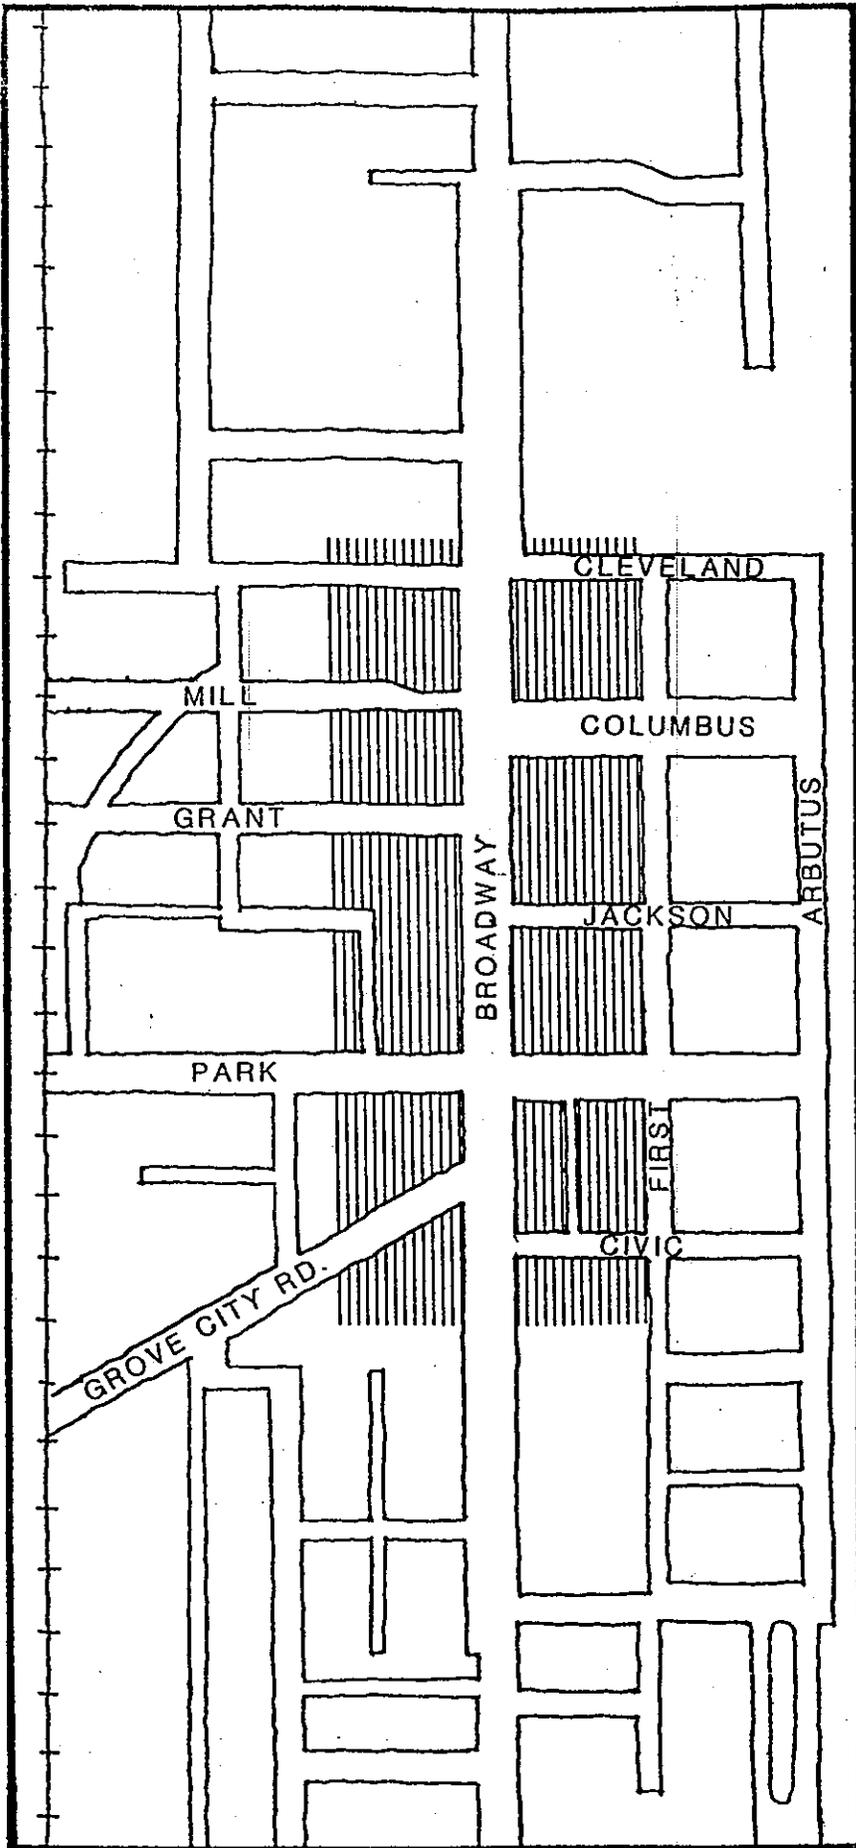
Illustration 1

TOWN CENTER
STUDY AREA

The study area selected to focus downtown redevelopment efforts consists of the most uniformly clustered properties presently zoned "CBD". This area, which is shown in Illustration I, extends one block east and west of Broadway. The northern limit is Cleveland Avenue, and the southern limit is Civic Place. This smaller district contains the properties which have primarily served retail or business uses throughout the history of the community.

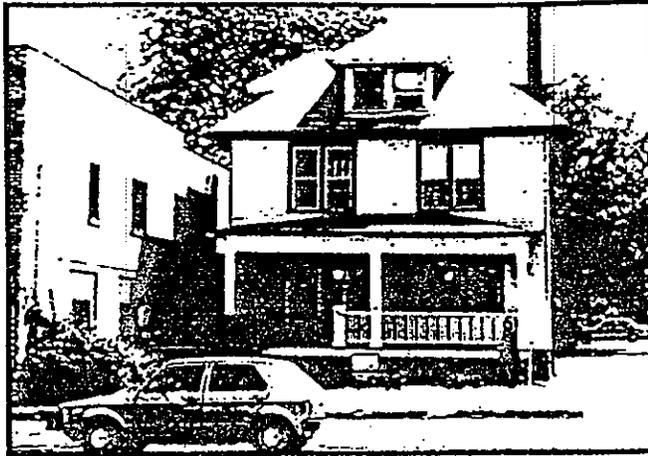
BUILDINGS OF MARGINAL VALUE

These are structures which possess problems because of re-use difficulties, significant code or maintenance problems, or placement in relation to property which should be assembled for redevelopment.

3980 Broadway	4000 Broadway	4002 Broadway	3985 Broadway
3981 Broadway	4023 Broadway	4027 Broadway	3387-89 Park Street

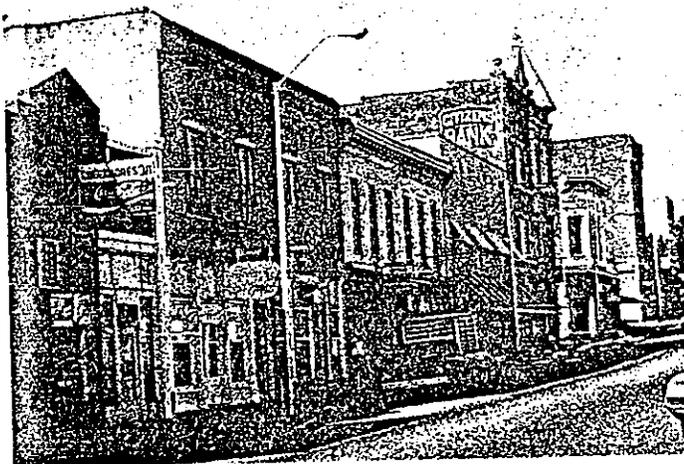
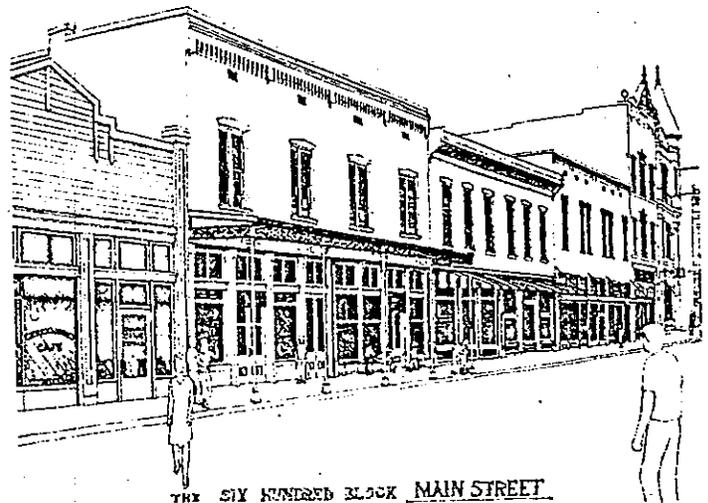
Figure 1. Inappropriate storefront alterations over the years—metal cladding, oversized signs and canopies—have detracted from the character of this historic district in Van Buren, Arkansas. A carefully considered rehabilitation plan for Main Street, including the removal of poorly designed signs, false fronts and the selection of an appropriate exterior paint color palette, serves to enhance the visual environment and preserves the district's sense of time and place. Photo above: Bob Dunn; Drawing, David Fitts

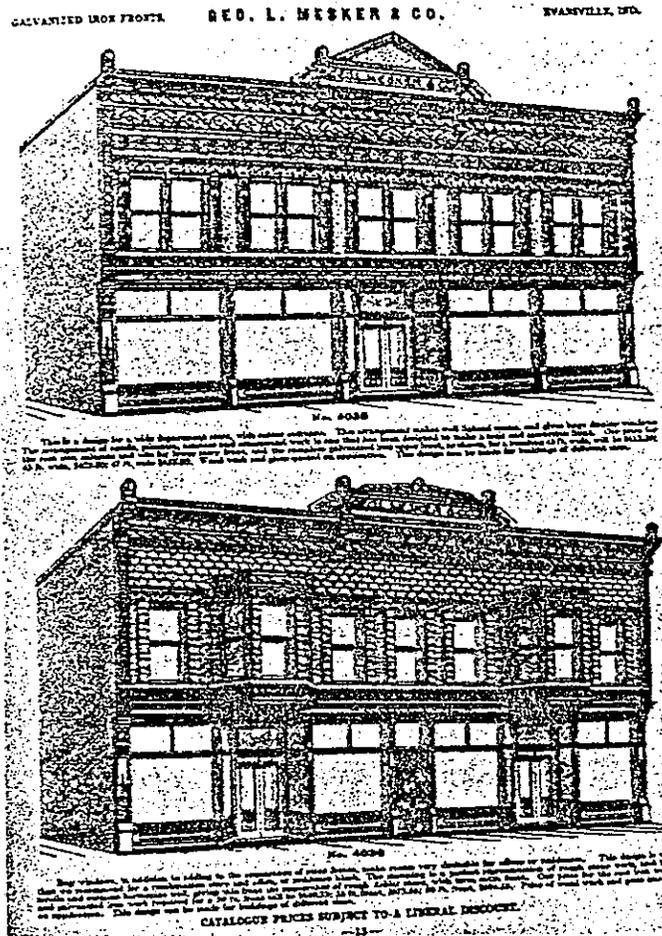
Figure 2. These 19th century galvanized iron storefronts could be purchased from George L. Mesker & Co. in Evansville, Indiana.

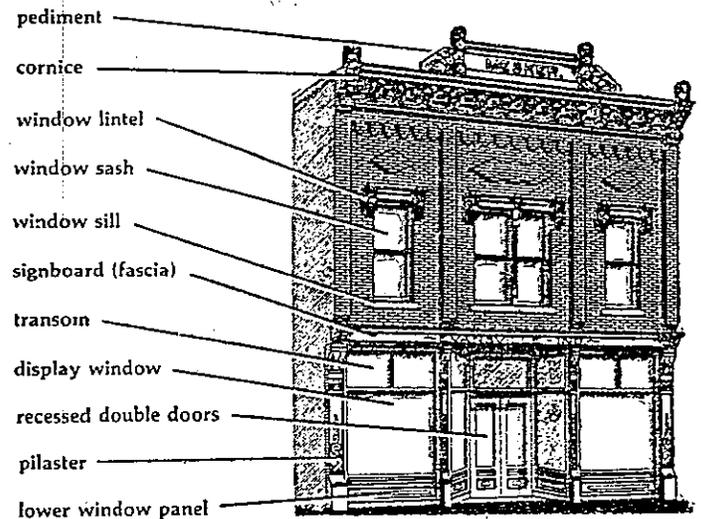
Figure 3. Become familiar with the architectural features typical of historic commercial buildings. A close look at a storefront's construction materials, features and relationship to the upper stories will help in determining how much of the original facade remains.

This particular storefront is No. 4016 in the George L. Mesker and Company catalog of 1905. One of Mesker's most popular designs, it featured cast-iron sills, columns and lintels, galvanized iron lintel and main cornice, window caps and pediment.

The typical 19th century storefront consisted of single or double doors flanked by display windows (see figure 3). The entrance was frequently recessed, not only to protect the customer from inclement weather but to increase the amount of space in which to display merchandise. In some cases an additional side door provided access to the upper floors. Thin structural members of cast iron or wood, rather than masonry piers, usually framed the storefront. The windows themselves were raised off the ground by wood, cast iron or pressed metal panels or bulkheads; frequently, a transom or series of transoms (consisting of single or multiple panes of glass) were

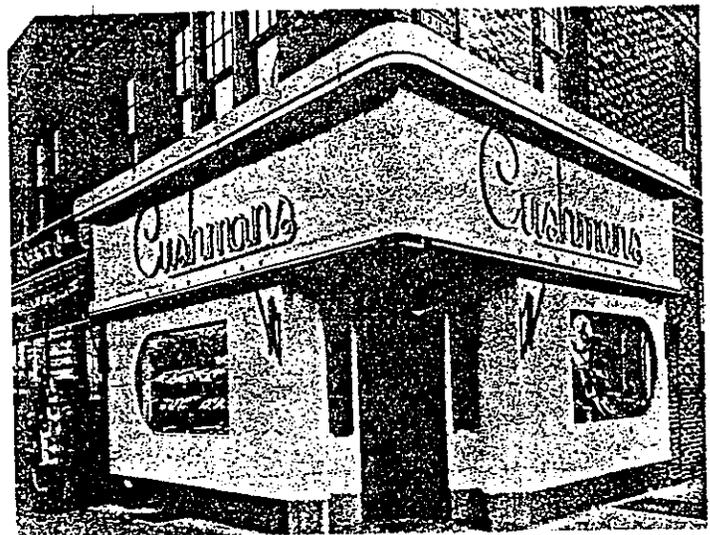
Figure 4. This storefront in New York City designed by Raymond Loewy typifies the streamlined look of the 1930's. Added to an earlier building, the front utilizes glass, stainless steel and neon to make a modern statement. This is a good example of a later storefront which has acquired significance and should be retained in any rehabilitation.

The first decades of the 20th century saw the growing use of decorative transom lights (often using small prismatic glass panes) above display windows; in some cases, these transoms could be opened to permit air circulation into the store. Electric incandescent lights enabled storeowners to call attention to their entrance and display windows and permitted nighttime shopping. In the 1920's and 1930's a variety of new materials were introduced into the storefront, including aluminum and stainless steel framing elements, pigmented structural glass (in a wide variety of colors), tinted and mirrored glass, glass block and neon. A bewildering number of proprietary products also appeared during this period, many of which went into storefronts including Aklo, Vitrolux, Vitrolite, and Extrudalite. Highly colored and heavily patterned marble was a popular material for the more expensive storefronts of this period. Many experiments were made with recessed entries, floating display islands, and curved glass. The utilization of neon lighting further transformed store signs into elaborate flashing and blinking creations. During this period design elements were simplified and streamlined; transom and signboard were often combined. Signs utilized typefaces for the period, including such stylized lettering as "Broadway," "Fino" and "Monogram." Larger buildings of this period, such as department stores, sometimes had fixed metal canopies, with lighting and signs as an integral component of the fascia (see figure 4).

In evaluating whether the existing storefront is worthy of preservation, recognize that good design can exist in any period; a storefront added in 1930 may have greater architectural merit than what is replaced (see figure 4). In commercial historic districts, it is often the diversity of

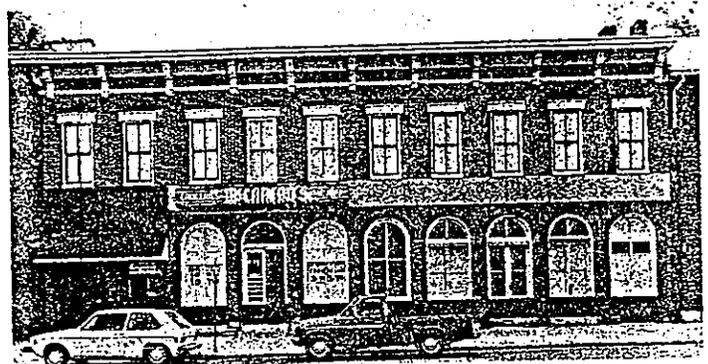
Figure 5. In some cases, as in the storefront on the extreme left, it is a simple matter to determine original appearance by looking at neighboring storefronts. Removal of the board and batten fasciaboard, pent roof, and "colonial" style door, all of which could be undertaken at minimal cost, would restore the original proportions and lines of the building. Photo: Day Johnston

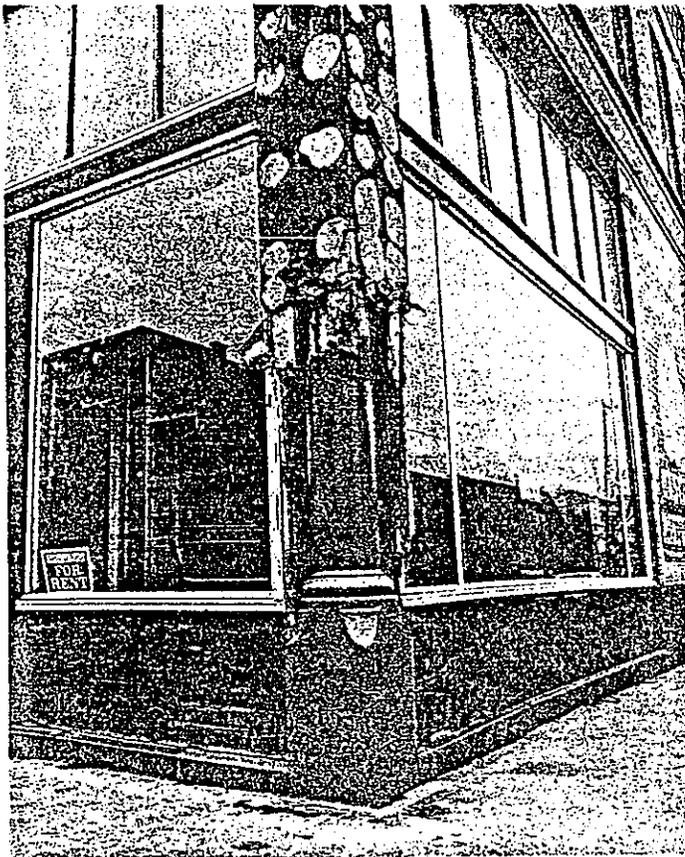
Figure 6. Storefronts of the 1940's, 50's, and 60's were frequently installed by attaching studs or a metal grid over an early front and applying new covering materials. If the existing storefront is a relatively recent addition with little or no architectural merit, begin by removing the covering materials in several places as was done here. If this preliminary investigation reveals evidence of an earlier front, such as this cast-iron column, carefully remove the later materials to assess the overall condition of the historic storefront. The black mastic visible on the lower masonry panels was used for installing pigmented structural glass. Some attachment methods for modern facings, such as mastic or metal lath, may have seriously damaged the original fabric of the building, and this must be taken into account in the rehabilitation process. Photo: Bob Dunn

tent and nature of rehabilitation work needed (see figure 6). In most cases, this examination is best undertaken by a qualified professional.

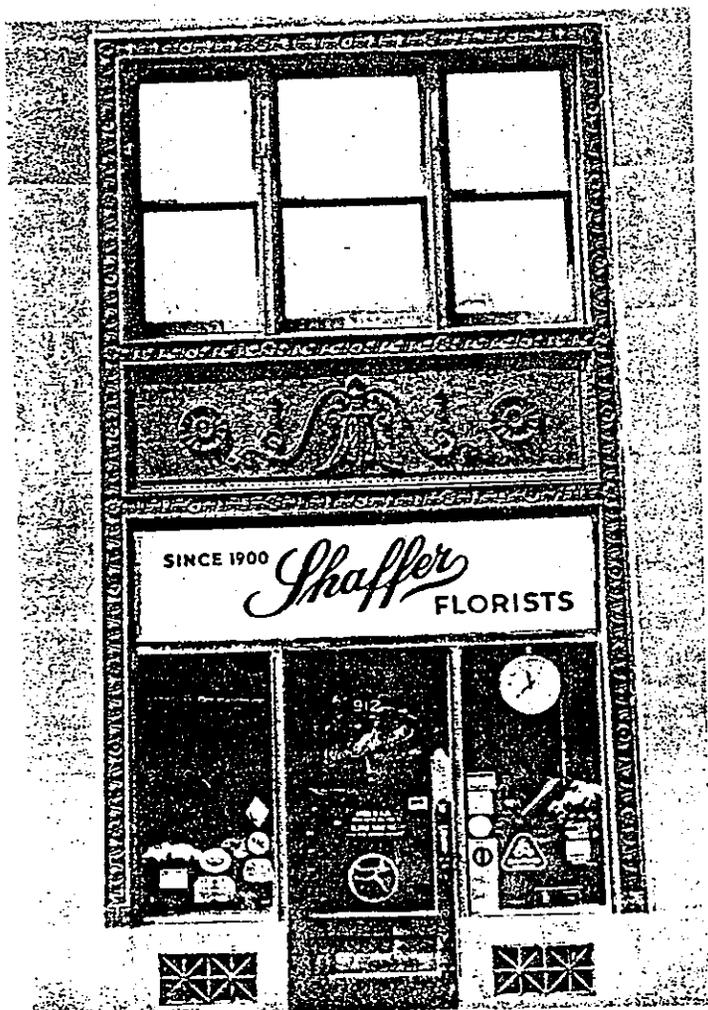
Figure 7. Part of a large office building constructed in Washington, D.C. in 1928, this finely detailed bronze storefront is typical of many constructed during this period. It should be noted that the original grilles, spandrel panel and window above are all intact. Photo: David W. Look, AIA

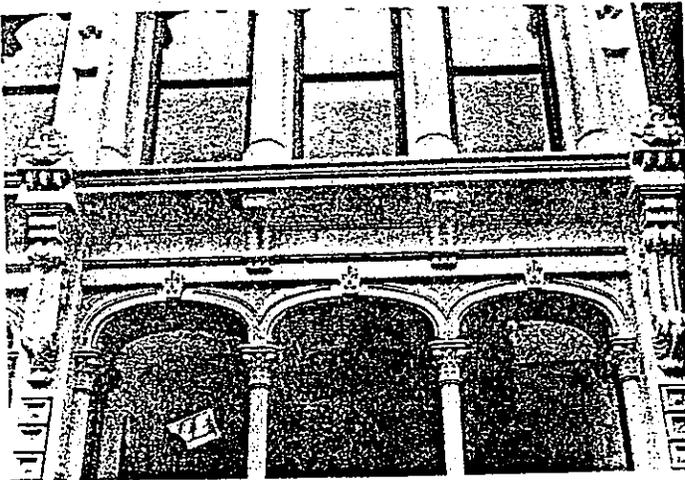
Figure 8. When the Grand Opera House in Wilmington, Delaware, was rehabilitated, missing cast-iron columns were cast of aluminum to match the original; in this particular case, because these columns do not carry great loads, aluminum proved to be successful substitute. Photo: John G. Waite

If metal components have deteriorated to a point where they have actually failed (or are missing), replacement is the only reasonable course of action. If the components are significant to the overall design of the storefront, they should be carefully removed and substituted with components that match the original in material, size and detailing (see figure 8).

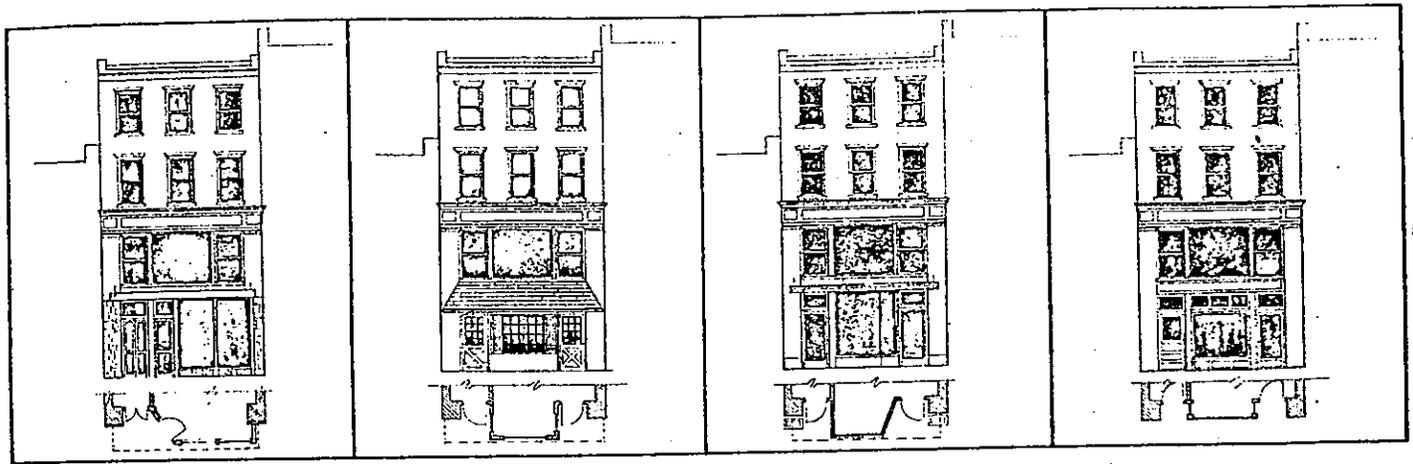
Figure 10. (A) This existing storefront, added in the 1950's to a late 19th century brick building, extends beyond the plane of the facade; faced with anodized aluminum and permastone, it does not contribute to the architectural and historic character of the building. (B) This replacement design uses "lumberyard colonial" detailing, such as barn-type doors, shutters, small paned windows, and a wood shake pent roof. The design, detailing, and choice of materials are clearly inappropriate to this commercial building. (C) This replacement design retains the 1950's projecting canopy but symmetrical placement of the doors relates well to the second floor windows above; this contemporary design is compatible with the scale and character of the building. (D) This replacement design accurately restores the original appearance of the building; based on historical research and physical evidence, it too is an acceptable preservation approach. Drawings: Sharon C. Park, AIA

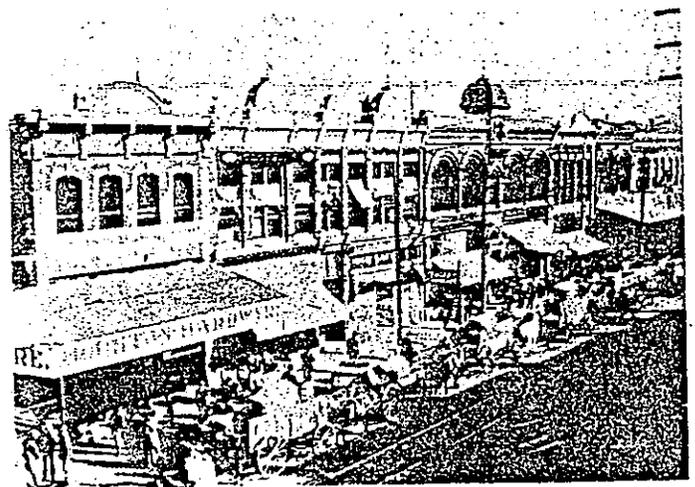
Figure 11. Try to locate old photographs or prints to determine what alterations have been made to the storefront and when they were undertaken. Awnings were common elements of storefronts at the turn of the century. They can be equally useful today.

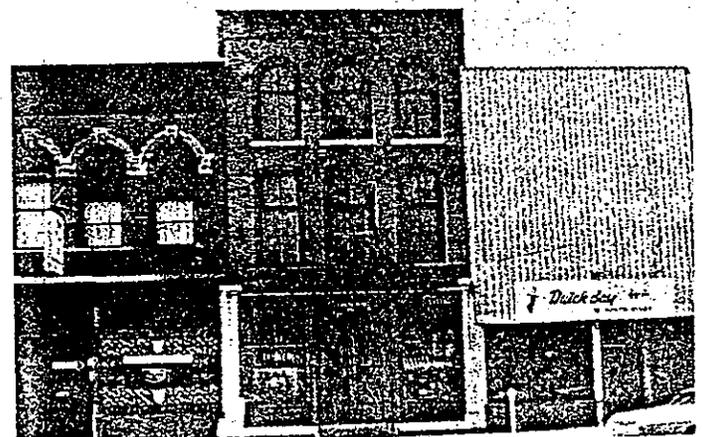
Figure 12. This photograph of three late 19th century commercial buildings clearly shows the impact of preserving and rehabilitating storefronts. The one on the right has been totally obscured by a "modern" front added in the 1950's. Although inappropriate alterations have taken place on the left storefront, it is still possible to determine the original configuration of the doors and display windows. The storefront in the middle has remained intact. Although in need of some minor maintenance work, the appeal of the original design and materials is immediately apparent.

A key to the successful rehabilitation of historic commercial buildings is the sensitive treatment of the first floor itself (see figure 12). Wherever possible, significant storefronts (be they original or later alterations), including windows, sash, doors, transoms, signs and decorative features, should be repaired in order to retain the historic character of the building. Where original or early storefronts no longer exist or are too deteriorated to save, the commercial character of the building should nonetheless be preserved—either through an accurate restoration based on historic research and physical evidence or a contemporary design which is compatible with the scale, design, materials, color and texture of the historic building. The sensitive rehabilitation of historic storefronts will not only enhance the architectural character of the overall building but will contribute to rejuvenating neighborhoods or business districts as well.
